FAILURE MODES OF LAMINATE STRUCTURES

Abstract

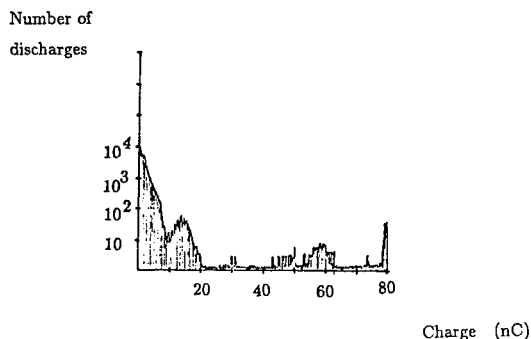
Figure 8. Partial discharge signature changes drastically just prior to cable failure.

Cables exposed to large numbers of shots exhibited continued change in their PD signatures. In particular, larger and larger PD events would be registered. For example, after 6000 impulses PDs extending to 80,000 pC occurred. These were measured just prior to cable failure and are shown in Fig. 8.

After continued aging (under ac, dc, or impulse) cable failure occurred. Under impulse, aging failure occurred after approximately 7000 shots and the mode was by puncture from an extended tree through the central Kapton layer to the upper electrode region. These failures occurred shortly after the appearance of the very large (80,000 pC) partial discharges in the ac monitoring tests.

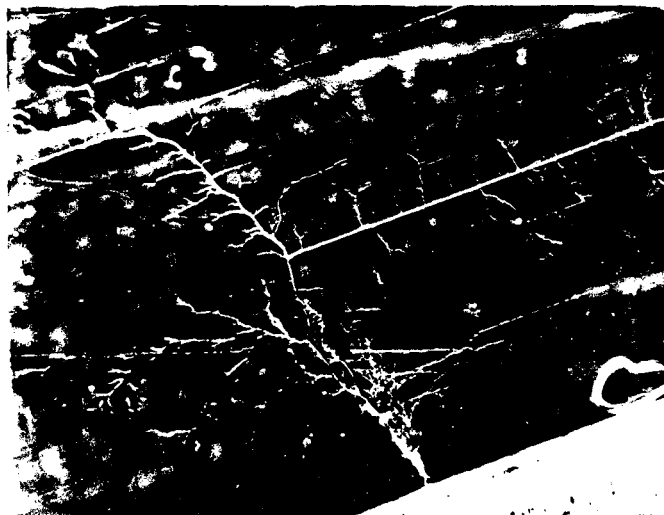
Figure 9. Impulse tree formation after 500 applied pulses.

Coincident with major changes in the partial discharge signature there were morphology changes in the dielectric. Electrical trees were observed originating at the conductor edges and propagating in the adhesive region between the Kapton layers. This tree growth was noticeable after 500 impulses. Figure 9 shows a typical tree case through an optical microscope. Tens of these trees were observed along the cable edge and they were typically 1 to 2 mm long.

When under impulse aging tests, dark room observations of the edge region showed visual light emissions from the tree regions. As the cable was exposed to more and more impulses, the light emission became brighter and was spread over more of the length of the edge region, indicating growth of the electrical trees.

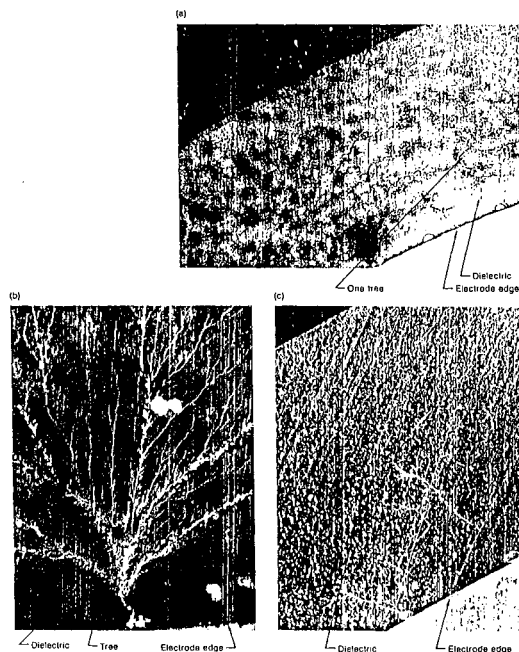
- o Tree development showed differing characteristics under ac, dc, and impulse stresses. Dc and impulse trees (Figure 10) were very similar, but ac (Figure 11) electrical trees were darker and had a larger degree of branching.

Figure 10. Comparison of dielectric degradation caused by three types of high-voltage stresses. We observed that, for two-conductor flat cable, trees form in the dielectric separating the conductors when (a) ac, (b) dc, and (c) impulsive high voltages are applied.
